GENERAL BELLHOUSING ALIGNMENT INSTRUCTIONS

DODGE, CHRYSLER & PLYMOUTH VEHICLES

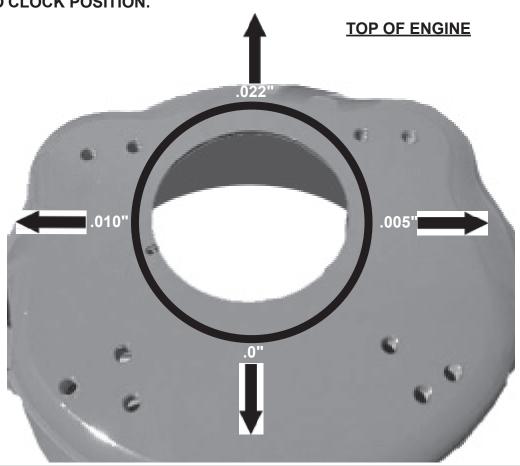
EXAMPLE

THE BELLHOUSING WAS OFFSET TOWARD TOP OF ENGINE AND SLIGHTLY TO THE LEFT (AS VIEWED FROM BEHIND). TO ALIGN THE BELLHOUSING, INSTALL TWO .014" OFFSET DOWEL PINS WITH THE MAXIMUM OFFSET POSITIONED ROUGHLY AT THE 5 O'CLOCK POSITION.

TO CORRECT OFF-CENTER CONDITION, SELECT THE OFFSET DOWEL PIN PAIR THAT IS CLOSEST TO ONE-HALF OF THE INDICATOR READING (I.E., IF READING IS .016", 1/2R=.008" USE .007" DOWELS. IF READING IS .024", 1/2R=.012" USE .014 DOWELS).
