GENERAL BELLHOUSING ALIGNMENT INSTRUCTIONS

FORD FLYWHEELS

Installation Notes for DF700000, DF559000, CFT260000, andCF260000

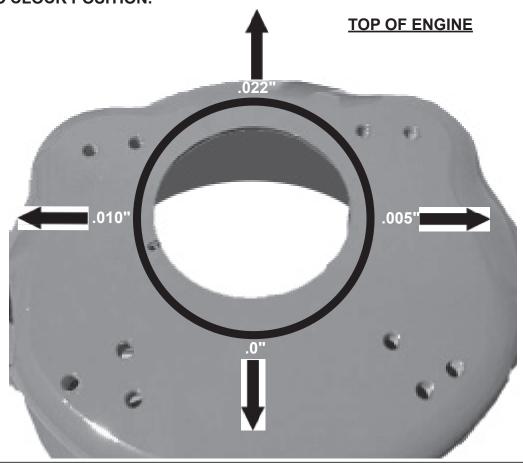
EXAMPLE

THE BELLHOUSING WAS OFFSET TOWARD TOP OF ENGINE AND SLIGHTLY TO THE LEFT (AS VIEWED FROM BEHIND). TO ALIGN THE BELLHOUSING, INSTALL TWO .014" OFFSET DOWEL PINS WITH THE MAXIMUM OFFSET POSITIONED ROUGHLY AT THE 5 O'CLOCK POSITION.

TO CORRECT OFF-CENTER CONDITION, SELECT THE OFFSET DOWEL PIN PAIR THAT IS CLOSEST TO ONE-HALF OF THE INDICATOR READING (I.E., IF READING IS .016", 1/2R=.008" USE .007" DOWELS. IF READING IS .024", 1/2R=.012" USE .014 DOWELS).

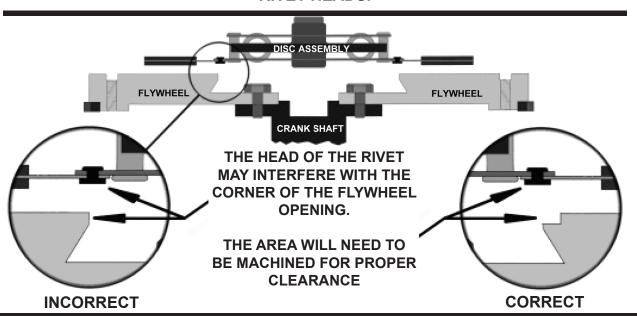
POSSIBLE INTERFERENCE MAY OCCUR BETWEEN THE CLUTCH DISC HUB TO MARCEL RIVETS DUE TO THE CENTER OPENING OF THE FLYWHEEL BEING INADEQUATE. THE RIVETS MAY RUB ON THE FACE OF THE FLYWHEEL. CAUSING THE ASSEMBLY TO RELEASE IMPROPERLY, MAKE NOISE DURING ENGAGEMENT, POSSIBLE FLYWHEEL AND DISC DAMAGE, AND/OR PREMATURE CLUTCH DISC FAILURE.

TO CORRECT THIS INTERFERENCE PROBLEM, A RELIEF MUST BE MACHINED INTO THE FLYWHEEL BY A QUALIFIED MACHINE SHOP. THE RELIEF SHOULD BE APPROXIMATELY .100" DEEP WITH SUFFICIENT DIAMETER TO CLEAR THE RIVET HEADS.

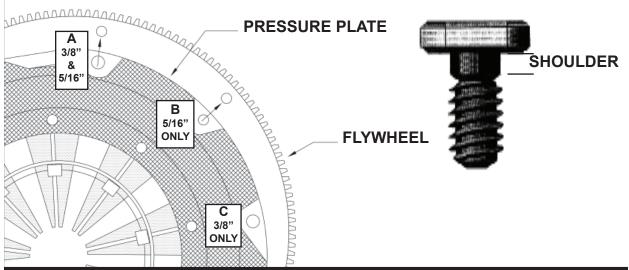
To avoid confusion on which holes to use when bolting the pressure plate to the flywheel. When installing a Centerforce pressure plate, the pressure plate has 9 bolt holes; only 6 of them will be used.

NOTE: 6 bolts are required to properly locate and fasten the pressure plate to the flywheel. Original equipment flywheels use (6) 5/16" shouldered bolts; bolt hole A & B (see above) to locate and retain the pressure plate. Some aftermarket flywheels may have a pattern aligning to the bolt holes A & C. The pressure plate may be bolted to such flywheels with shouldered 3/8" bolts in holes A & C.

You must use shoulder type bolts to mount the pressure plate to the flywheel. This will keep the clutch aligned properly on the flywheel and increase the shear strength.
