# IMPORTANT

FOR ALL FORD MOTOR VEHICLES USING THROW OUT BEARING PART NUMBER N1714 OR O.E.M. TYPE EQUIVALENT DESIGN (PICTURED BELOW), WHICH IS A SELF ALIGNING TYPE THROWOUT BEARING.

198F0014 CENTERFORCE TECH. LINE (928) 771-8422 WWW.CENTERFORCE.COM

### GENERAL BELLHOUSING ALIGNMENT INSTRUCTIONS

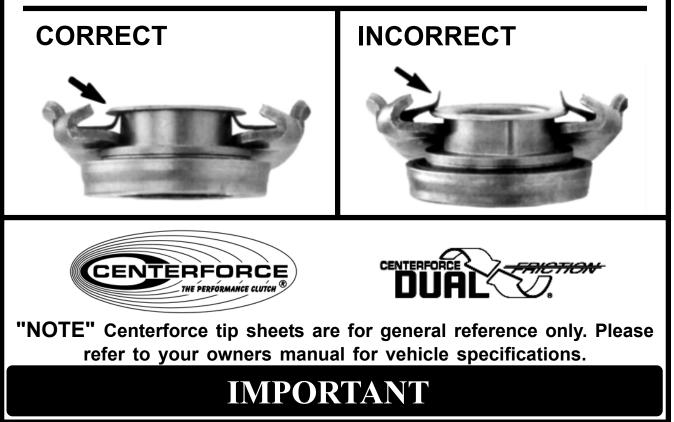
**NOTE:** SELF ALIGNING TYPE THROWOUT BEARINGS WHEN REMOVED FROM THE BOX MAY APPEAR TO BE OFF CENTER, HOWEVER, THEY ARE NOT DEFECTIVE AND WILL PROPERLY ALIGN DURING USE.

THE FORK SPRING CLIPS MUST BE INSTALLED BETWEEN THE THROWOUT BEARING COLLAR FLANGES. IF THE CLIPS ARE INSTALLED ABOVE THE TOP FLANGE AS SHOWN BELOW, PROPER ADJUSTMENT CANNOT BE MADE.

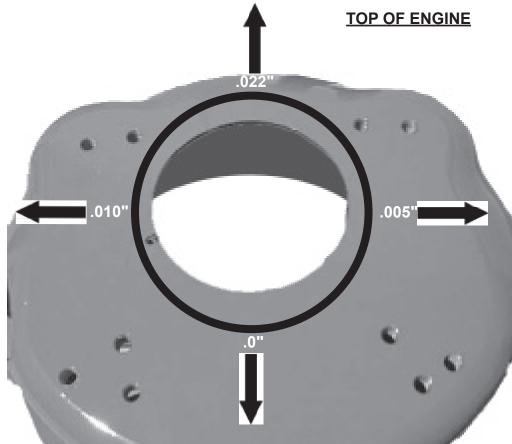
#### EXAMPLE

THE BELLHOUSING WAS OFFSET TOWARD TOP OF ENGINE AND SLIGHTLY TO THE LEFT (AS VIEWED FROM BEHIND). TO ALIGN THE BELLHOUSING, INSTALL TWO .014" OFFSET DOWEL PINS WITH THE MAXIMUM OFFSET POSITIONED ROUGHLY AT THE 5 O'CLOCK POSITION.

TO CORRECT OFF-CENTER CONDITION, SELECT THE OFFSET DOWEL PIN PAIR THAT IS CLOSEST TO ONE-HALF OF THE INDICATOR READING (I.E., IF READING IS .016", 1/2R=.008" USE .007" DOWELS. IF READING IS .024", 1/2R=.012" USE .014 DOWELS).

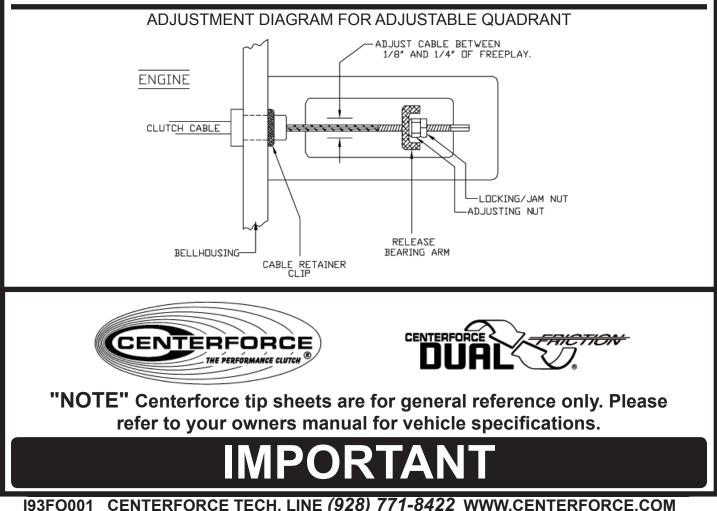
<u>CARS WITH AN AFTER MARKET (ONE PIECE) ADJUSTABLE QUADRANT</u>- (MANUAL ADJUSTMENT). MOVE THE CABLE ADJUSTING NUT (AT THE RELEASE BEARING ARM) TO OBTAIN 1/8" MINIMUM TO 1/4" OF FREEPLAY IN THE CABLE (SEE DIAGRAM). AT THIS SETTING THE CLUTCH SHOULD EN-GAGE AT ONE THIRD TO ONE HALF OF THE PEDAL TRAVEL DISTANCE UP FROM THE FLOOR BOARD. IF THE ENGAGEMENT POINT DOES NOT FALL WITHIN THIS RANGE; LOOSEN THE ADJUSTING NUT (ADD SLACK TO THE CABLE) TO LOWER THE POINT OF ENGAGEMENT, OR THE OPPOSITE, TIGHTEN THE CABLE (MAKING SURE TO MAINTAIN THE PROPER FREEPLAY IN THE CABLE), TO <u>RAISE</u> THE ENGAGEMENT POINT UNTIL THE PROPER SETTING IS ACHIEVED. BE SURE TO LOCK THE CABLE ADJUSTING NUT WITH THE JAM NUT WHEN THE ADJUSTMENT IS COMPLETED.

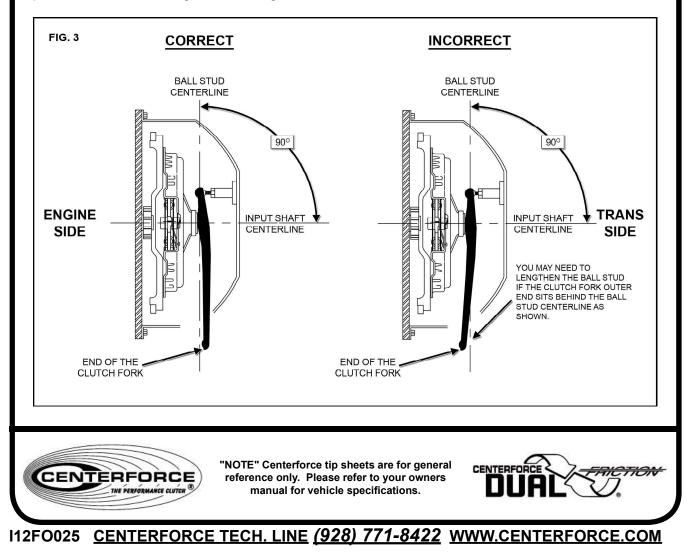
#### MECHANICAL CLUTCH LINKAGE GEOMETRY FINAL CHECK

Once the clutch assembly, release bearing, clutch fork and Bellhousing are bolted in place you can visually ensure the clutch fork ball stud is adjusted properly. Do not connect the remainder of the clutch linkage at this point. Move the clutch fork by hand until the release bearing contacts the clutch fingers. The outer end of the clutch fork should be pointed towards the transmission, behind the ball stud center as shown in FIG 3. If the outer end of the clutch fork is ahead of the ball stud centerline (pointing towards the engine), your clutch linkage is incorrect. Please re-visit the clutch fork pivot ball adjustment instructions or call the Centerforce Tech line at (928) 771-8422 for further assistance. Next, fully retract the release bearing away from the clutch fingers and visually check to insure that you have at least 1/4" clutch wear allowance gap between the release bearing and the clutch fingers. Once the geometry is correct, connect the remainder of the clutch linkage and then adjust to where the clutch engagement point is approximately half-way up the pedal travel. Small adjustments can be made to suit individual driving preferences. Throughout the service life of your clutch, be sure to periodically check the wear allowance gap and adjust as needed. Caution! If the clutch engagement point is at or near the top of your clutch pedal travel – your clutch may be pre-loaded (release bearing too close or touching the clutch fingers). Continued operation with the clutch in a pre-loaded condition will void the warranty and cause poor performance as well as significant damage.
