FOR ALL FORD MOTOR VEHICLES USING THROW OUT BEARING PART NUMBER N1714 OR O.E.M. TYPE EQUIVALENT DESIGN (PICTURED BELOW), WHICH IS A SELF ALIGNING TYPE THROWOUT BEARING.

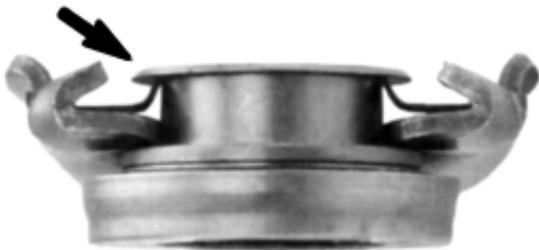
CORRECT

THE FORK SPRING CLIPS MUST BE INSTALLED BETWEEN THE THROWOUT BEARING COLLAR FLANGES. IF THE CLIPS ARE INSTALLED ABOVE THE TOP FLANGE AS SHOWN BELOW, PROPER ADJUSTMENT CANNOT BE MADE.
